Mobile Intel[®] Pentium[®] II Processor Specification Update

Release Date: December 2002

Order Number: 243887-047

The Mobile Pentium[®] II processor may contain design defects or errors known as errata which may cause the product to deviate from published specifications. Current characterized errata are documented in this Specification Update.

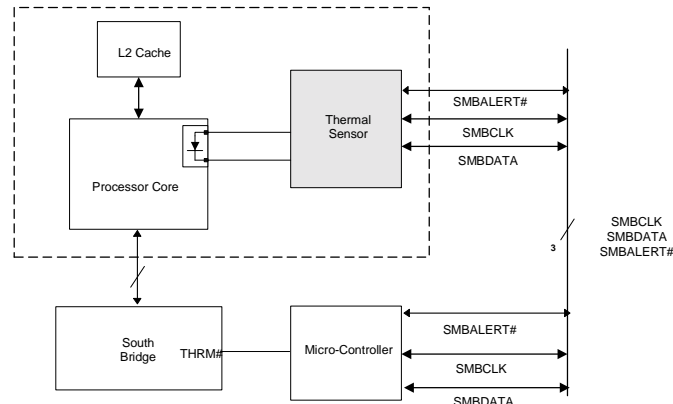
Figure 1. An Example of Microcontroller Driven Thermal Management

B30. Thermal Sensor May Assert SMBALERT# Incorrectly

Problem: The Mobile Pentium II processor and the Pentium II Processor Mobile Module have a thermal sensor that monitors the processor core's temperature. Please note that desktop systems could have a similar thermal device. The thermal sensor asserts SMBALERT# if the processor temperature exceeds the temperature limits set in the Alarm Threshold Registers (T_{HIGH} , T_{LOW}). It also sets the corresponding Status Register bits to identify the cause of the interrupt. Figure 1 gives one example of the how the SMBALERT# signal could be used in a system.

Under the conditions described below, the thermal sensor incorrectly generates the SMBALERT# interrupt. All of the following conditions must be met to trigger a false interrupt:
